ARBORICULTURAL REPORT TO BS5837:2012

SWANSEA NORTH ENERGY MANAGEMENT FACILITY

FOR STATKRAFT UK LTD

JUNE 2020

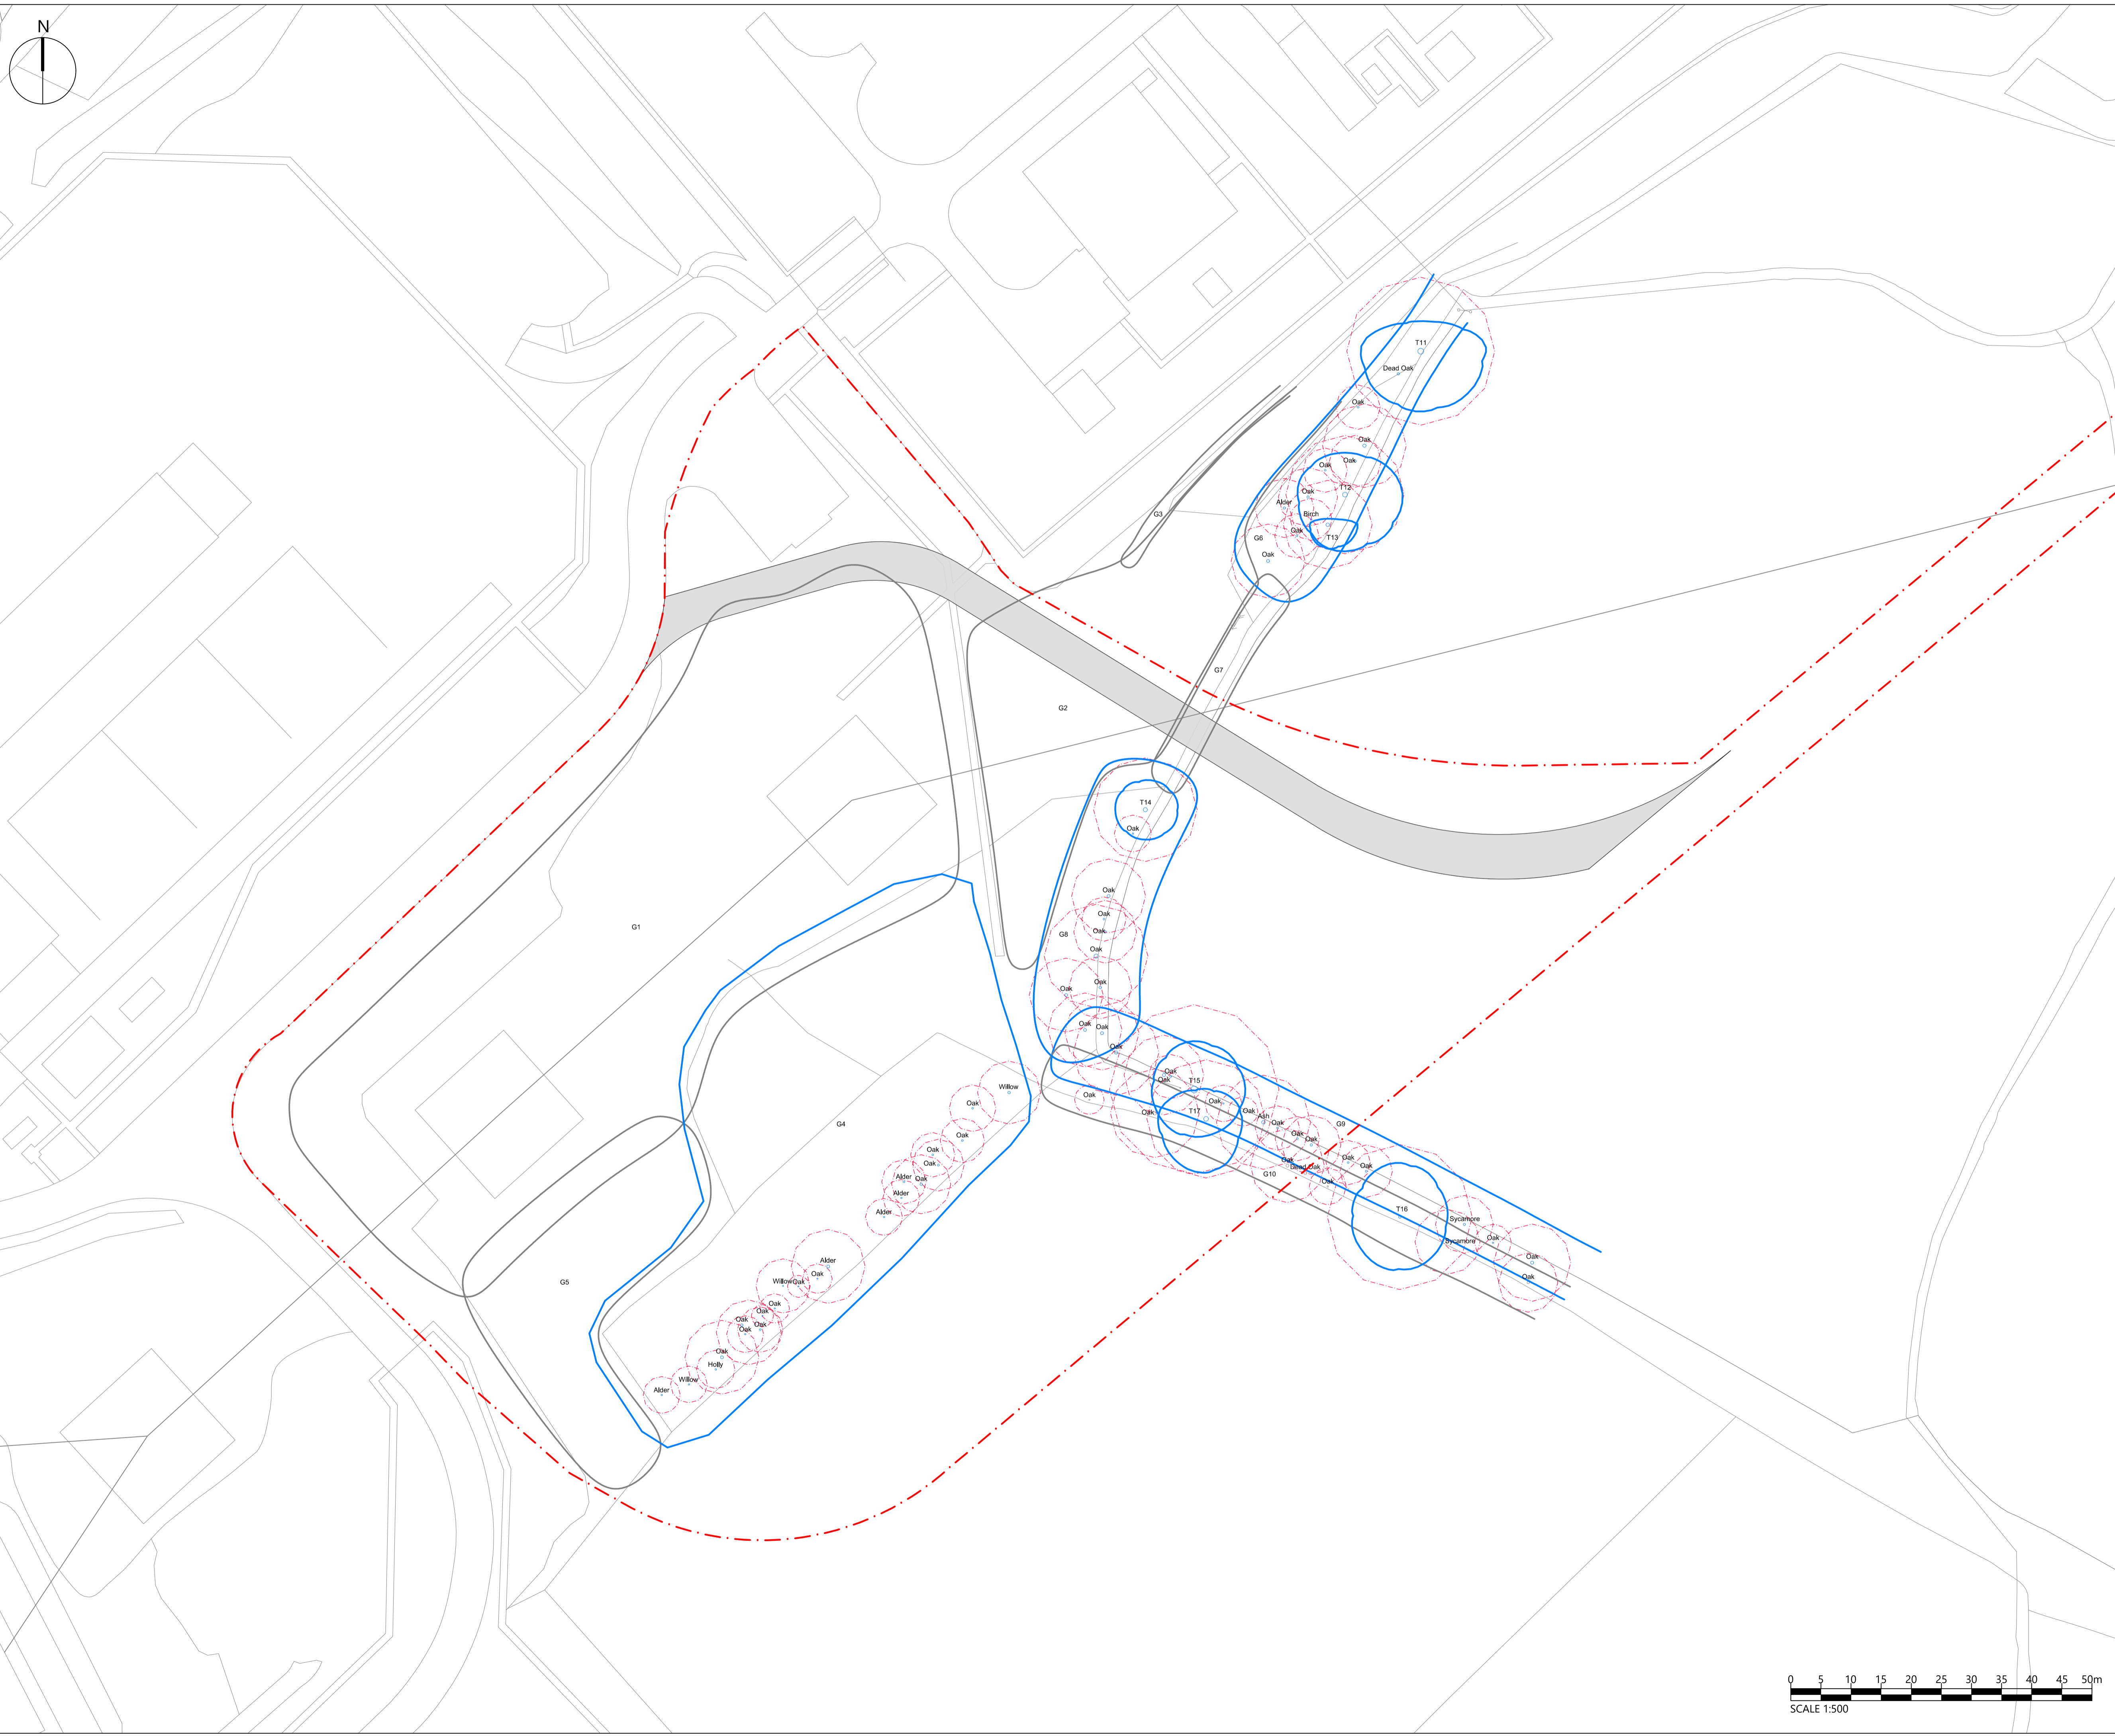
Appendix 4: Tree Constraints Plan

The tree Root Protection Area (RPA) detailed on the Tree Constraints Plan at Appendix 4 has been used as a layout design tool, to inform on the area around a tree where the protection of the roots and soil structure is treated as a priority.

The RPA for each tree has been plotted as a polygon centred on the base of the stem. Due to the presence of roads, structures, topography (and past tree management) the RPA is likely to be a simplified representation of the tree roots actual morphology and disposition. However, detailed modifications to the shape of the RPA would largely be based on conjecture and so have been avoided.

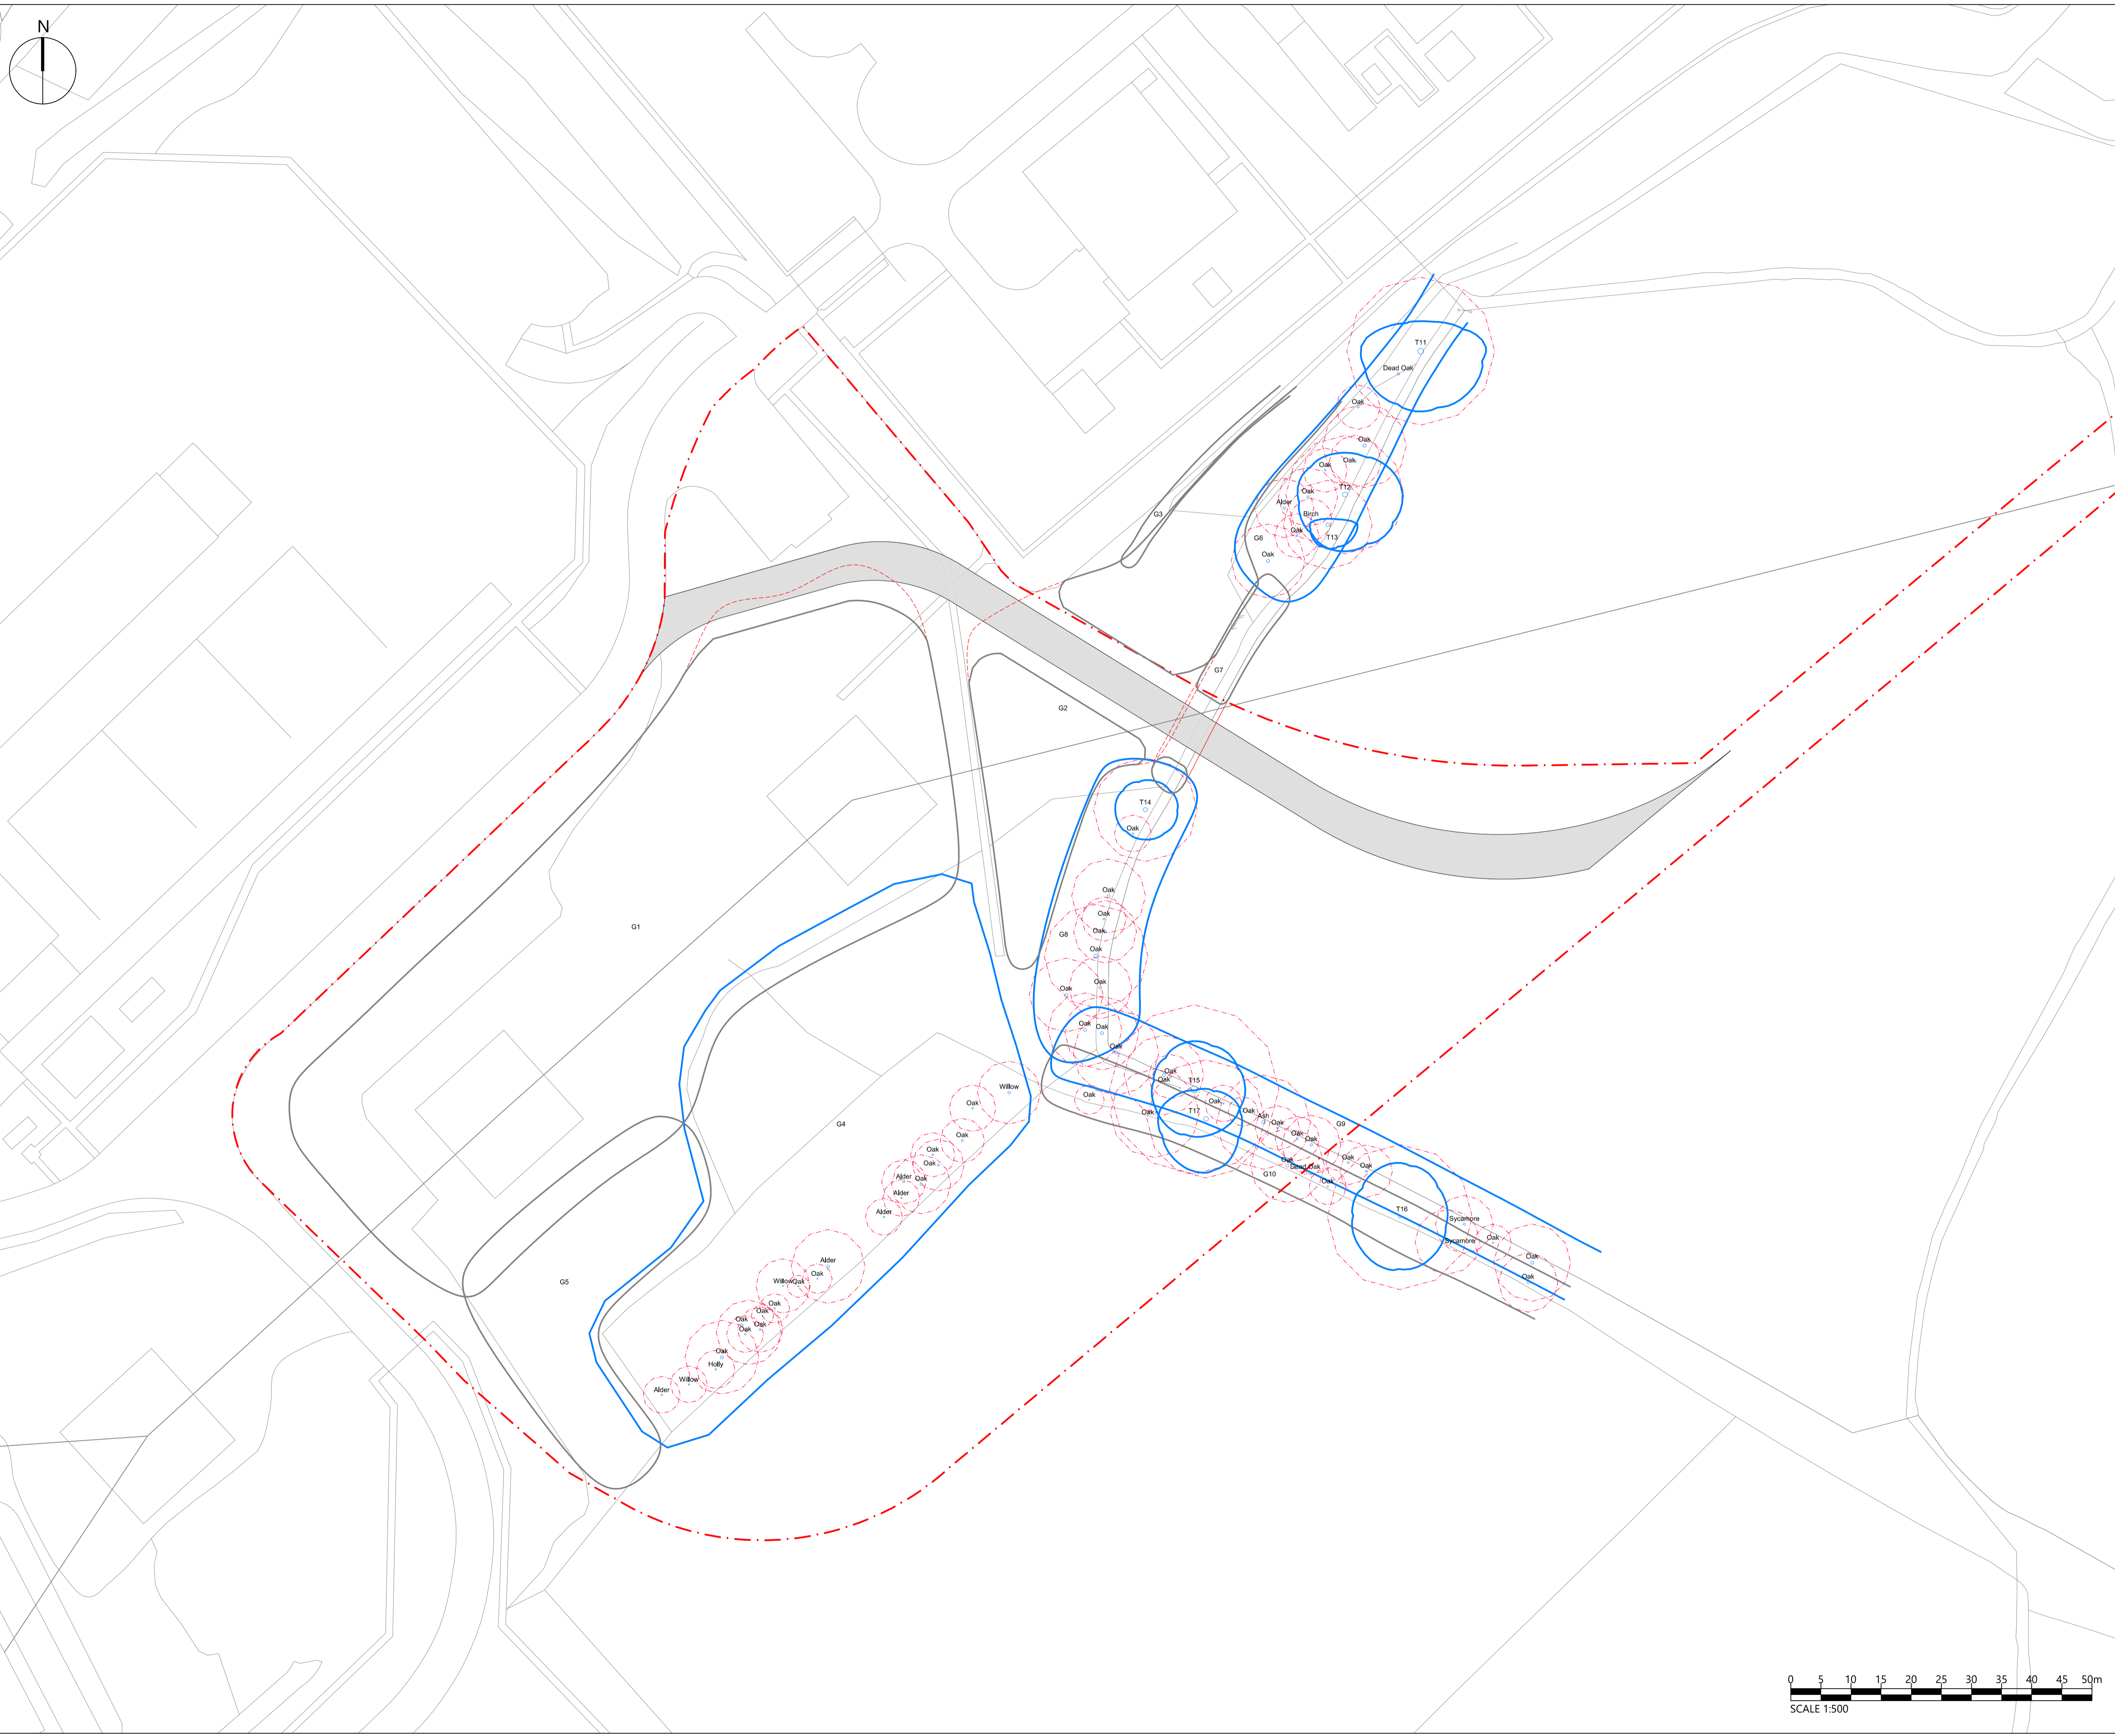
Appendix 5: Tree Impacts Plan

From assessing the new development proposals, the partial removal of 3 tree groups will be required as they are situated in the footprint of the development or their retention and protection throughout the development is not suitable.

The tree groups that require partial removal are G1, G2 and G7, they are comprised of low value young to semi mature natural regeneration or recent plantings and their partial removal will have little negative impact.

The tree Root Protection Area (RPA) detailed on the Tree Plans at Appendix 4 and 5, has been used as a layout design tool, to inform on the area around a tree where the protection of the roots and soil structure is treated as a priority. As such, no significant negative indirect impacts have been identified.

The retained trees may require protection by fencing in accordance with BS 5837: 2012, during the construction phase.

If required by the Local Planning Authority, an associated Arboricultural Method Statement, detailing protective fencing specifications and construction methods close to the retained trees can be provided.
